ATTACHMENT B

VISUAL SITE ~~INSPECTION SUMMARY AND~~ PHOTOGRAPHS

FACILITY NAME: Union Carbide Corporation - Electronics Division
EPA I.D. NUMBER: OH0004167383
LOCATION CITY: Cleveland
STATE: Ohio

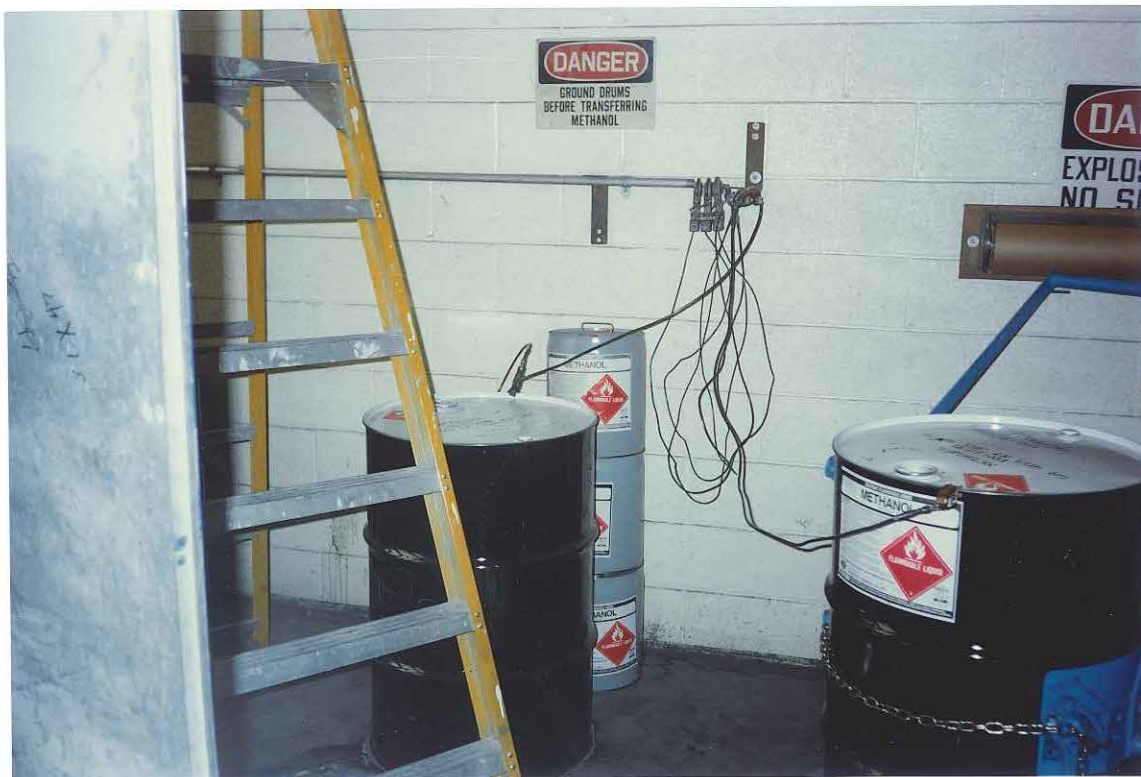
Photograph No. 24

Description: The area is inside Building 10 on a concrete floor. The drum on the left is empty and the drum on the right, with a chain around it, is partially filled with spent methanol. Once the drum is filled, it is moved to the hazardous waste storage Pad A (SWMU 1). The two drums are connected to wires for grounding purpose.
